General Contractors and Owners Part ways on Playground Surfacing

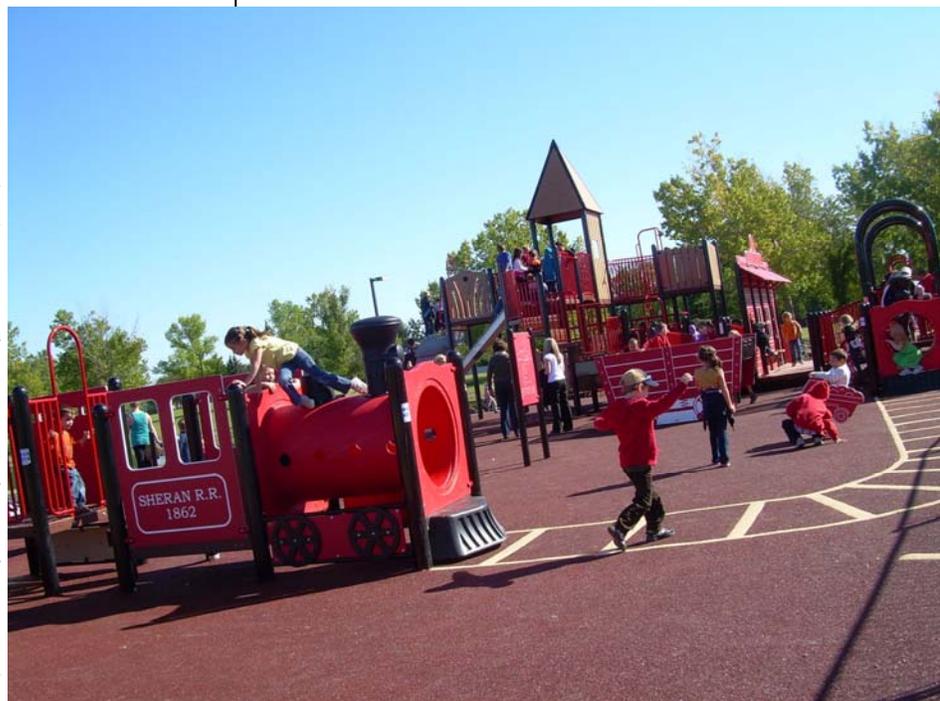
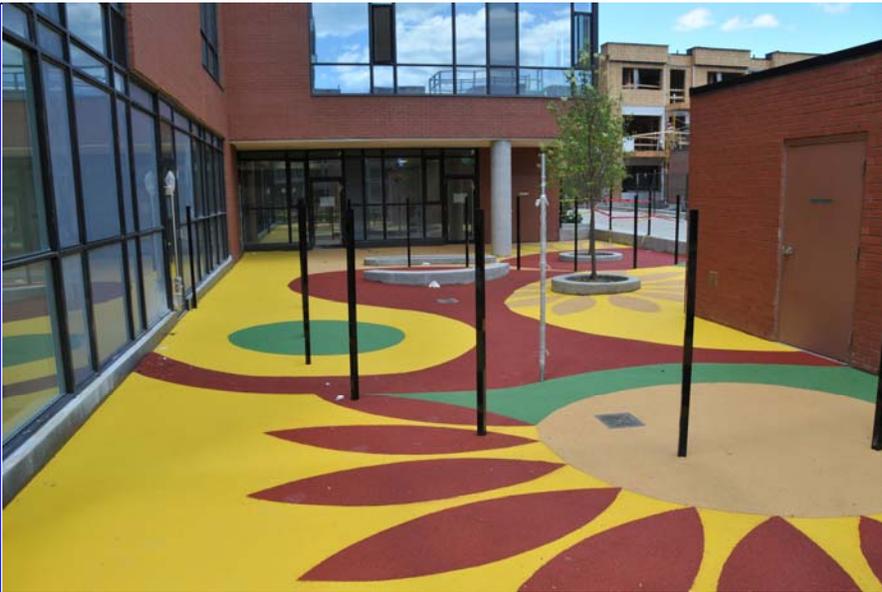
Rubber Tiles or Mats are the agglomeration of rubber crumb and binder that is pressed to a fixed configuration in a controlled factory setting and should have more consistent performance properties than PIP, but these systems can also have problems associated with conformance to standards. Visually a Tile is a two part product

consisting of a smooth upper sheet with shaped legs on the underside. Although the rubber sheet does flex, it is the legs that provide the bulk of the impact attenuating properties. If dirt or other contamination is allowed to gather around the legs, either by penetration from the surface above or by sand or gravel where the Tiles are not installed on concrete or asphalt, the impact attenuation properties can quickly be lost. At this point there is a failure of the system. Additionally breakage of the legs over time can also cause a failure. Depending on how the Tiles have been installed or connected to one another, failed surfacing can be removed, corrective measures taken and the Tile replaced. This may or may not be at the expense of the owner or General Contractor as many tile manufacturers offer a warranty that does not extend beyond their loading dock or there is a limited warranty and the longer it has been installed, the less that warranty coverage is. This might be a problem for the General Contractor, where they have a 100% replacement built into their contract terms.

Additional problems associated with tiles is that their thickness is changed depending upon drop height of the play structures and gapping of the tiles as a result of changes in temperature or moisture. Varying the thickness of a Tile may requires changes in the grade of the base under the tiles or a single thickness of tile is utilized for the entire playground, providing superior performance for low structures and marginal and potentially failing performance at high structures. This can be confirmed through testing in the field at the time of installation. With the gapping, a serious problem can occur where the gap may be larger than the 1/2" and there-

fore not meet the ADA or while the gap is open, dirt and other contamination can enter the gap and result in a location where the impact attenuation will not meet the required standards. Some manufacturers use metal clips to connect their Tiles, however when they do gap the metal clips become exposed to a child and a new hazard is created.
